Manhole Inspection Summary

Manhole # S33CC_024MH

Location Address: **MARTIN LUTHER KING BLVD**

Cross Street: **W CHASE ST**

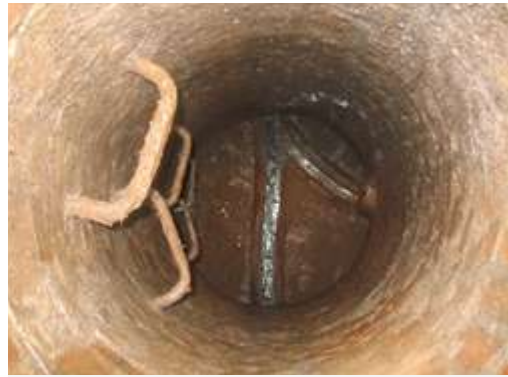
Top View

Corroded steps. Bench debris.

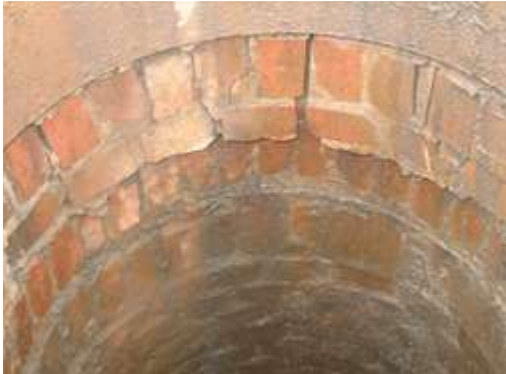
Defect

Frame leaks. Adjustment deterioration and infiltration. Corbel infiltration - other side.

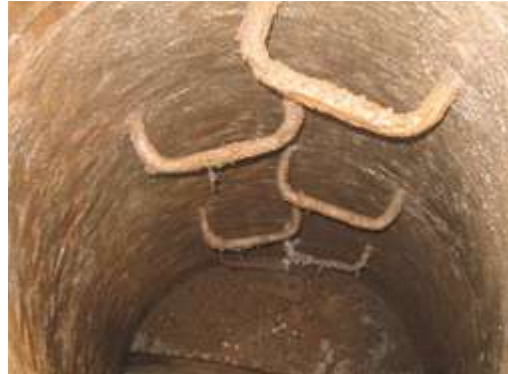
Defect

Corroded steps. Adjustment and Corbel infiltration.

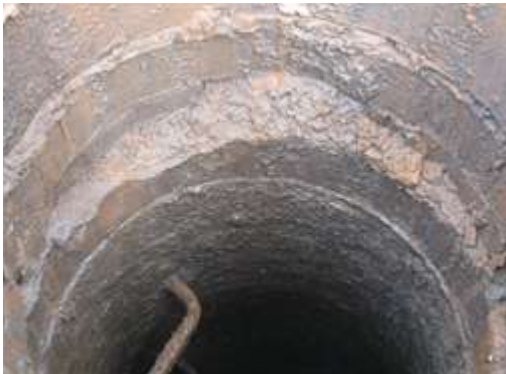
Defect

Frame leaks. Frame offset. Adjustment infiltration.

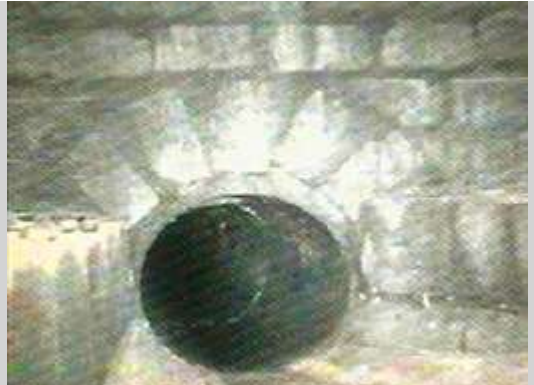
8 in. Circular Gravity Sewer Pipe Out @ 12 O'Clock

Infiltration: **Evidence** Pipe Seal Cond: **Unknown**
